## **TECHNICAL REPORT TR-2352-ENV**

# **Application of a Bimetallic Treatment System (BTS) for PCB Removal from Older Structures on DoD Facilities**

November 2010

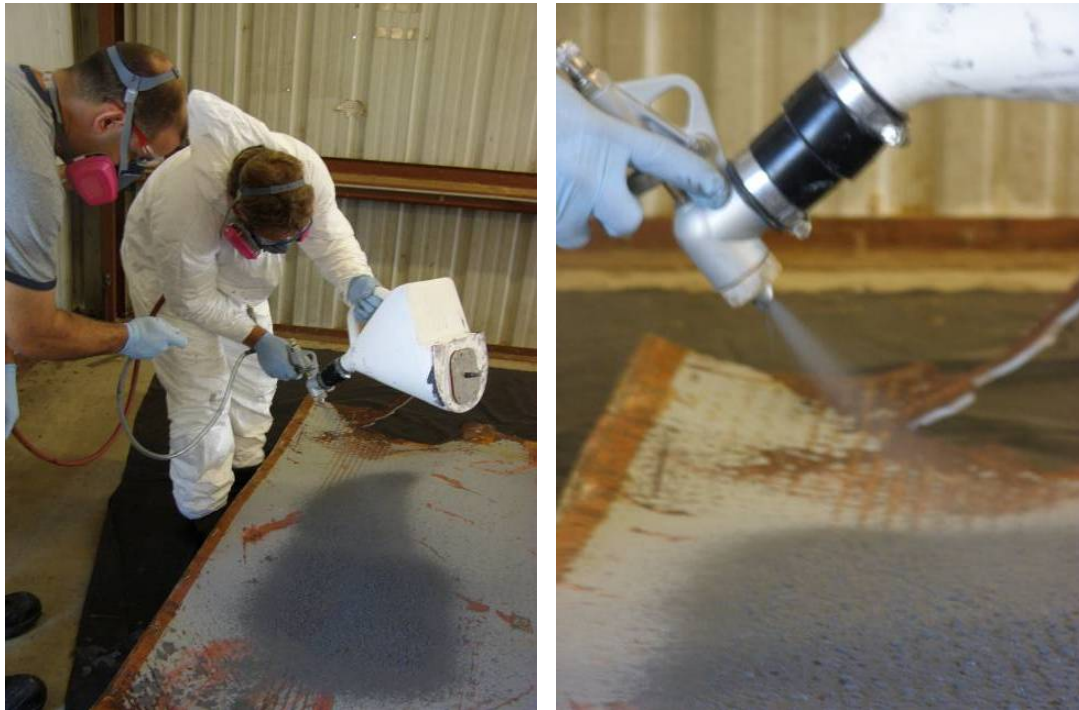
Figure 5-9. Application of BTS to VIB samples using pressurized sprayer

A modified pressurized sprayer was used in the initial application of BTS (Figure 5-9). Additional solvent was added to the paste (prior to application) to facilitate spraying. A manual application technique (using a trowel) was also used. There was a difference in the thickness of the BTS when applied using the two application methods and it was later shown that the thickness of the BTS affects treatment (see Section 5.6.3 Paste Optimization Studies). Because the thickness of the sprayed BTS was so much smaller than that applied via a trowel (approximately 1/8 to 1/4 of an inch versus 3/8 to 1/2 of an inch, respectively), a majority of the sections were treated with BTS applied manually using a trowel, as shown in Figure 5-10.

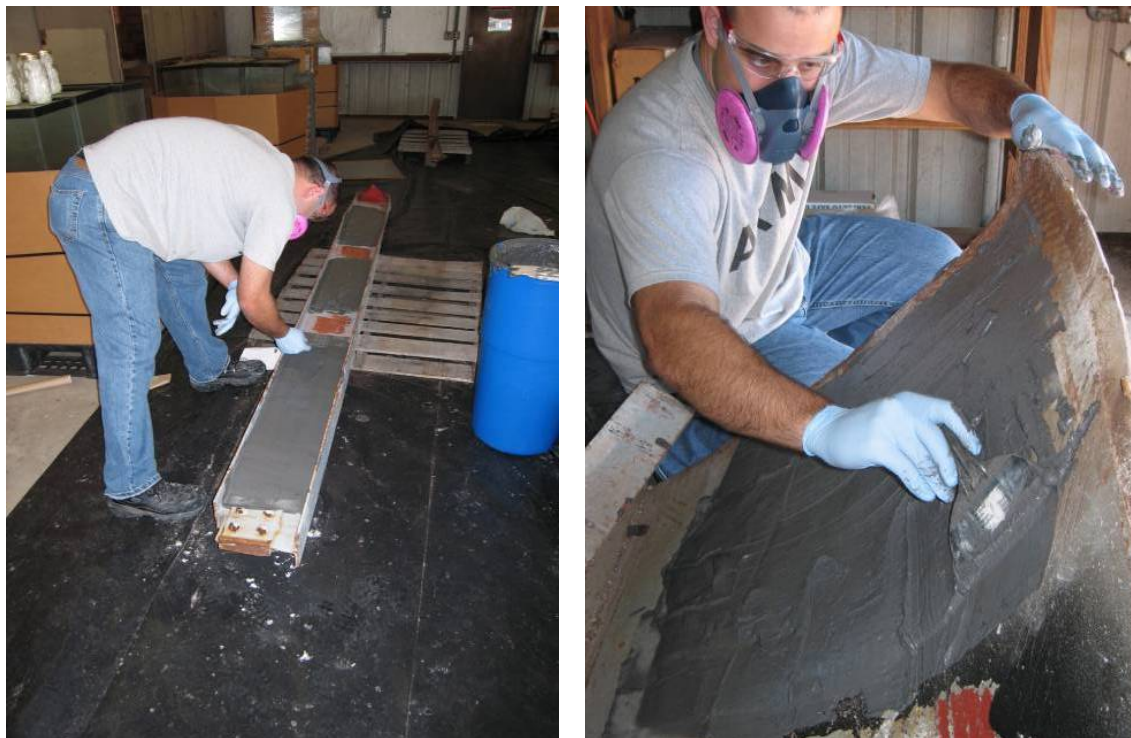
Figure 5-10. Manual application of BTS to VIB samples.

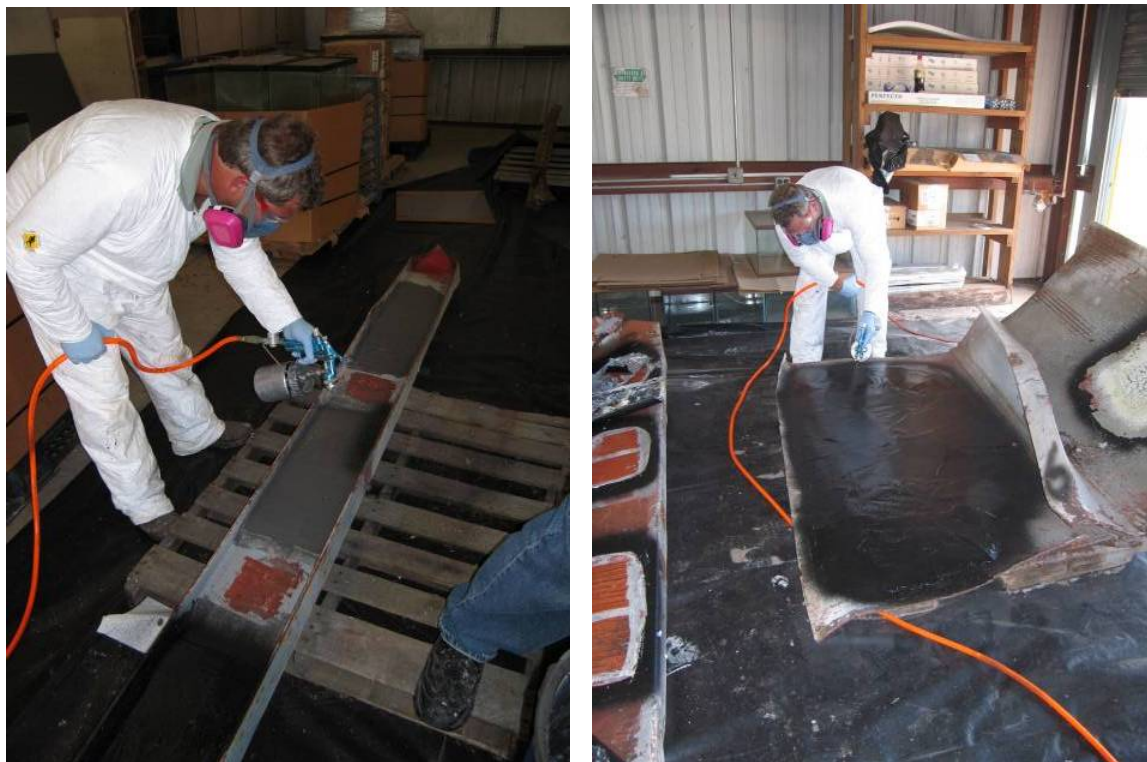
**Figure 5-11.** Application of coating material using HVLP sprayer.

Sealants were used to coat the surface of the BTS paste in an attempt to prevent loss of solvent from the BTS following application. Two sealants were tested, 1) a silicone roof sealant (Sil) (mineral spirits-based); and 2) a vinyl polymer truck bed liner (VP) (toluene-based). These were diluted with solvents (ethanol or mineral oil for the Sil, acetone for the VP) in a 3:1 coating: solvent ratio in order to allow for ease of spraying during application. They were both applied using a high volume/low pressure (HVLP) sprayer. Approximately 5 coatings of each material were applied to the BTS surfaces and at least an inch beyond the edge of the BTS paste, to seal the edge of the paste. Care had to be taken when applying the initial coating of sealant and the sealant allowed to set for a short period of time (roughly 5 minutes) before additional coatings could be used. If a heavy coating (high flow rate) of sealant was applied at the start, it tended to displace the BTS from the surface that was being treated. Once the sealant was in place, the BTS paste was allowed to react for the specified times (one, two three or four weeks). Figure 5-11 shows the application of the truck bed liner sealant material.

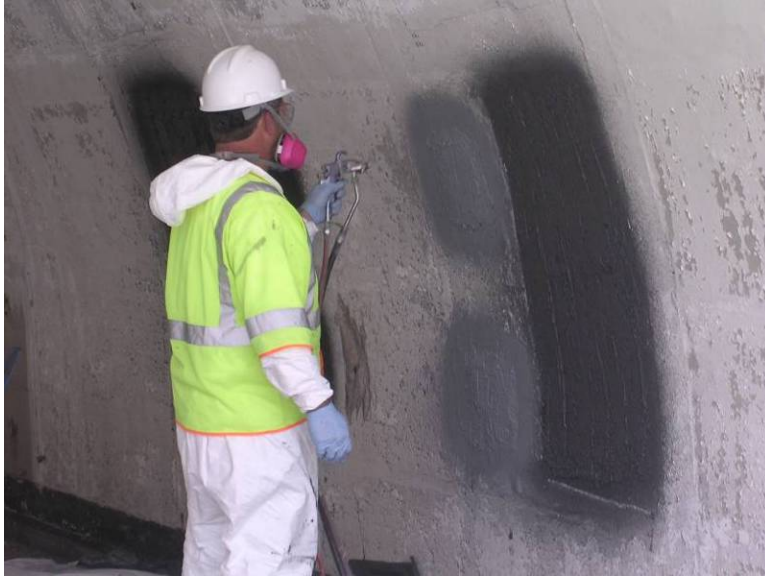
Figure 5-14. Silicon sealant application with spray gun.

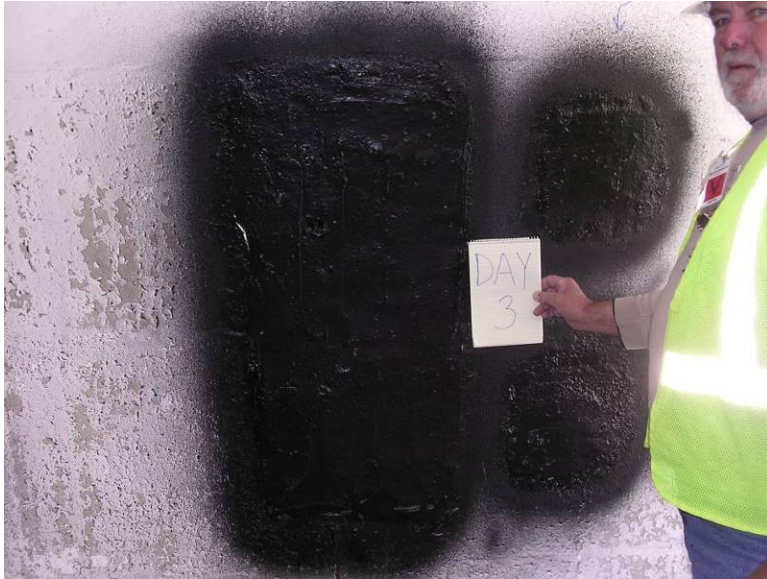
Figure 5-15. Three days post BTS application, NM-VP in 6810-11.

The state of the treated sections at the 6810-11 test site can be seen in the following three figures which show them three days after treatment. Figure 5-15 shows the NM-VP site, Figure 5-16 shows the Mg/Pd-silicon site and Figure 5-17 shows the Mg/Pd-VP site. As the figures show, all of the sealants are intact with no cracks.

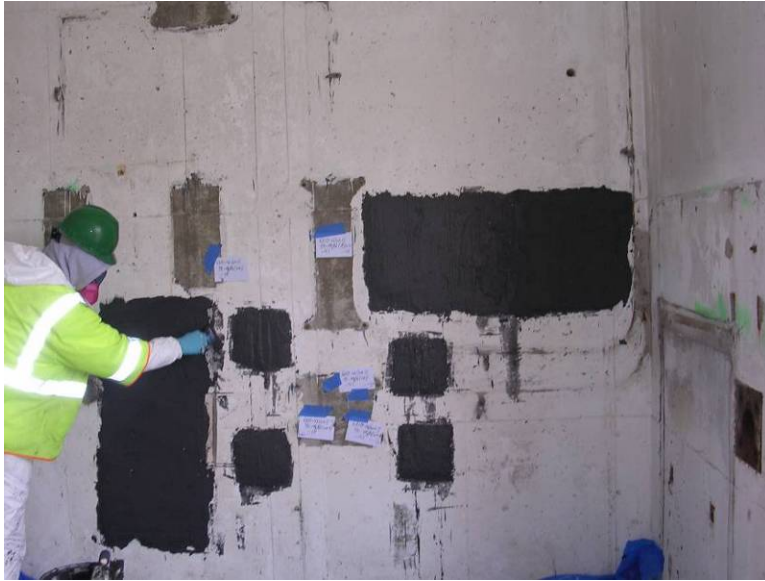
Figure 5-18. Application of Mg/Pd BTS prior to sealing with VP or silicon sealant, 6810-36.

Figure 5-18 shows the application of the Mg/Pd-BTS using a trowel. Figure 5-19 shows the NM-VP (non metal paste sealed with VP) test location in 6810-36 three days after treatment and Figure 5-20 shows the Mg/Pd-VP (active metal paste sealed with VP) test location after three days of treatment. The 1 ft<sup>2</sup> section three days after BTS application and sealed with silicon polymer (Mg/Pd-Sil) is shown in Figure 5-21. The 3 ft<sup>2</sup> section, three days after treatment is shown in Figure 5-22. As can be seen, the sealant on the 3 ft<sup>2</sup> Mg/Pd-Sil section began to fail immediately and could not be saved for testing after three weeks of treatment. Thus it was decided to switch the planned sections and test it after one week of treatment. The 6810-36 test site was visited each day for one week and when any cracks appeared in the sealant, attempts were made to repair them as described in the 6810-11 site section above.

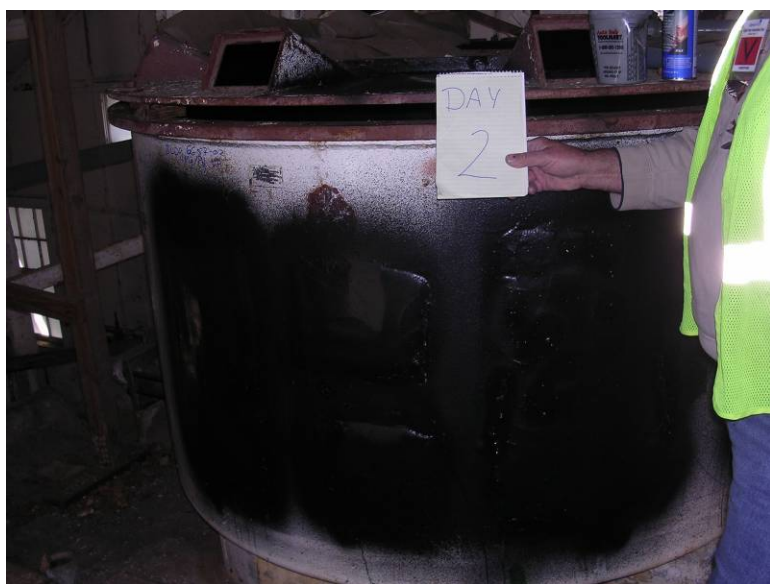
Figure 5-26. Large tank treated with Mg/Pd-VP and NM-VP, two days after application.

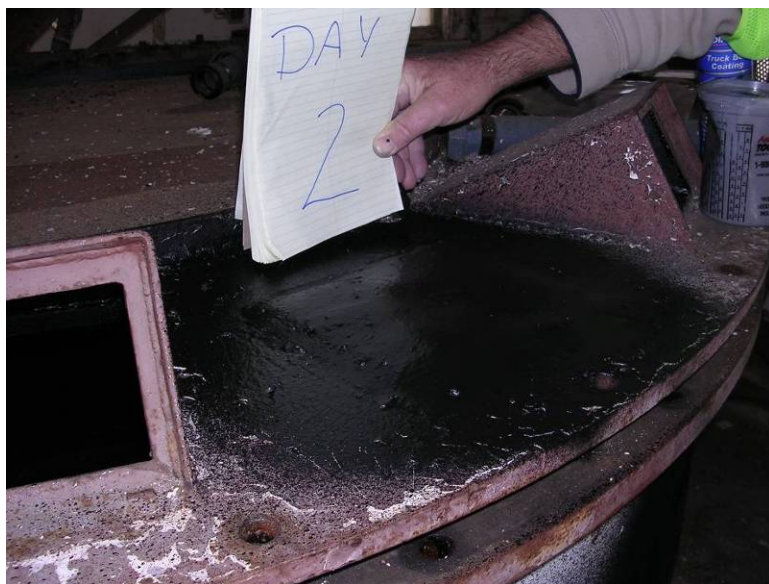
Figure 5-27. Large tank lid treated with Mg/Pd-VP, two days after application.

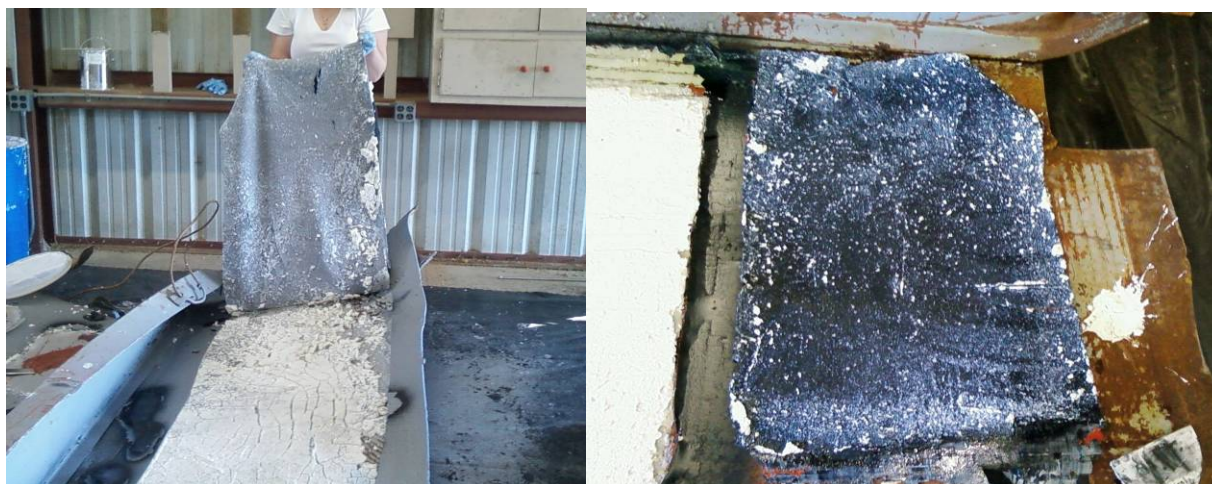
Figure 5-34. Removal of coating material after exposure to BTS

Samples were taken periodically over the period of a month for analysis of the both the treated paint and exposed BTS material and sealant. Analysis of paint samples were performed by Kennedy Space Center, while analysis of the BTS itself was performed at the University of Central Florida. Prior to sampling, the coating layer (VP or Sil) was removed. It proved possible to remove this in a single piece, helping to keep the sample below intact for analysis. Figure 5-34 shows the coating material being removed.

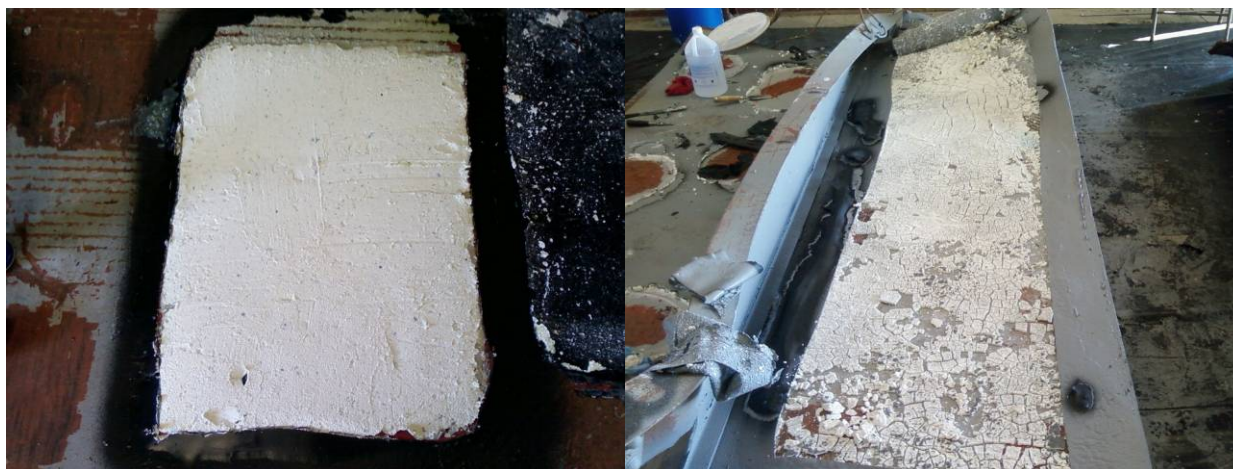
Figure 5-35. Varying appearance of BTS (non-metal paste) after exposure to paint and removal of sealant.

The BTS material itself showed variability in appearance/moisture level upon removal of the coating, most likely related to amount of time exposed and some possible cracks in the sealant which allowed solvent evaporation. However, several samples still appeared moist after 3 weeks of exposure, indicating that the solvent adsorption material added to the BTS formulation was helping to retain a portion of the ethanol: limonene solvent. This is crucial in order for degradation of the PCBs to occur *in situ*. Examples of the paste after exposure are shown in Figure 5-35.

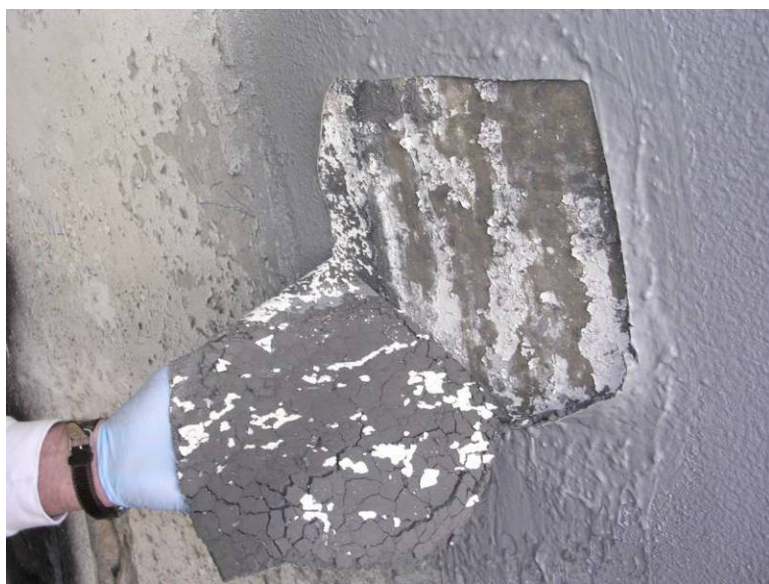
Figure 5-41. One week post application, during sampling, Mg/Pd-silicon, 6810-11.

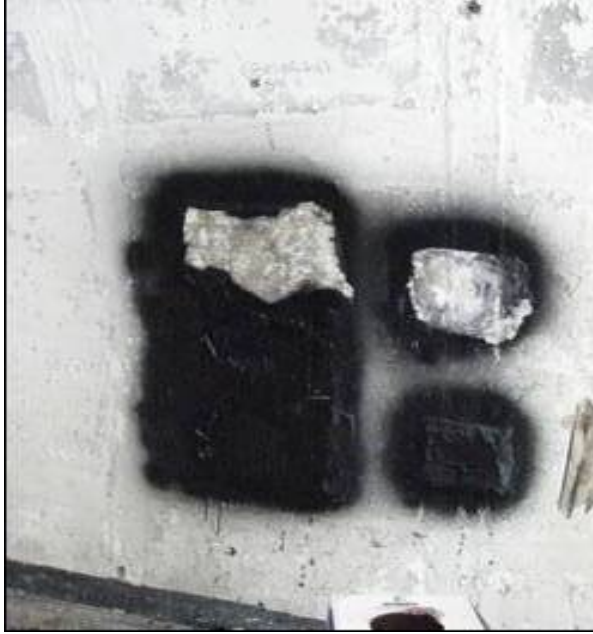
Figure 5-42. Mg/Pd-VP, two weeks after application, 6810-11.

Figure 5-42 shows the 6810-11 Mg/Pd-VP treatment two weeks after treatment. It can be seen that part of the VP sealant had failed. Thus it was decided to take the two week sample from the 3 ft<sup>2</sup> section and the three-week sample from a 1 ft<sup>2</sup> section (originally identified for sampling at two weeks).

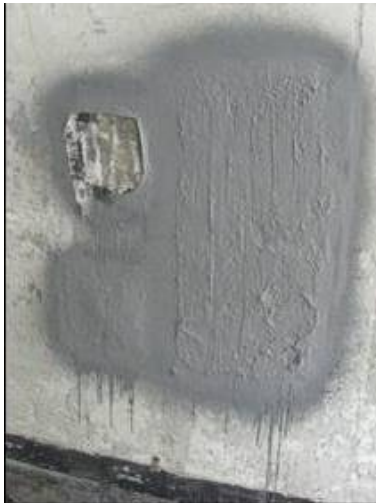
Figure 5-43. Mg/Pd-silicon prior to two week sampling event, 6810-11.

Figure 5-43 shows the Mg/Pd silicon site prior to taking week two samples and that the sealant had not failed at this location. Figure 5-44 shows the Mg/Pd-silicon site during the two week sample was taken.

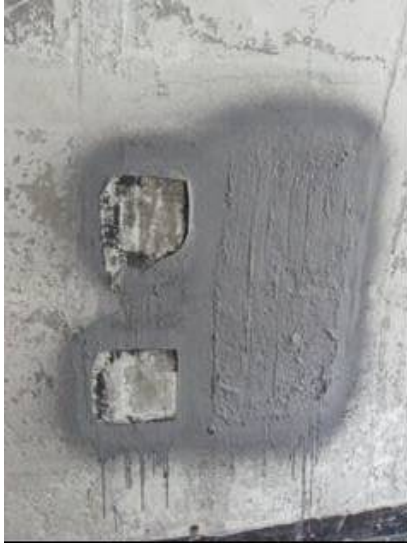
Figure 5-44. Mg/Pd-silicon after two week sampling event, 6810-11.

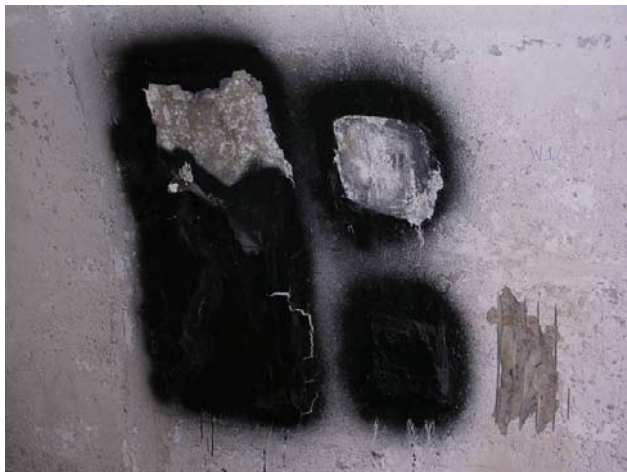
Figure 5-45. Mg/Pd-VP prior to three week sampling event, 6810-11.

Figure 5-45 shows the status of the 6810-11 Mg/Pd-VP treatment site prior to sampling after three weeks of treatment. It can be seen that the condition of the sealant did not change very much between weeks two and three. The three week sample for this treatment location was taken from the 1 ft<sup>2</sup> area that was still intact. Figure 5-46 shows the NM-VP treatment location, prior to taking the three week sample. It can be seen that a portion of the VP sealant broke loose between week two and week three sampling. Figure 5-47 shows the Mg/Pd-silicon treatment area and it can be seen that the 3 ft<sup>2</sup> section is still intact. Figure 5-48 shows the Mg/Pd-silicon site after sampling. Figure 5-49 shows a sample of concrete being taken from the Mg/Pd-silicon site after three weeks of treatment.

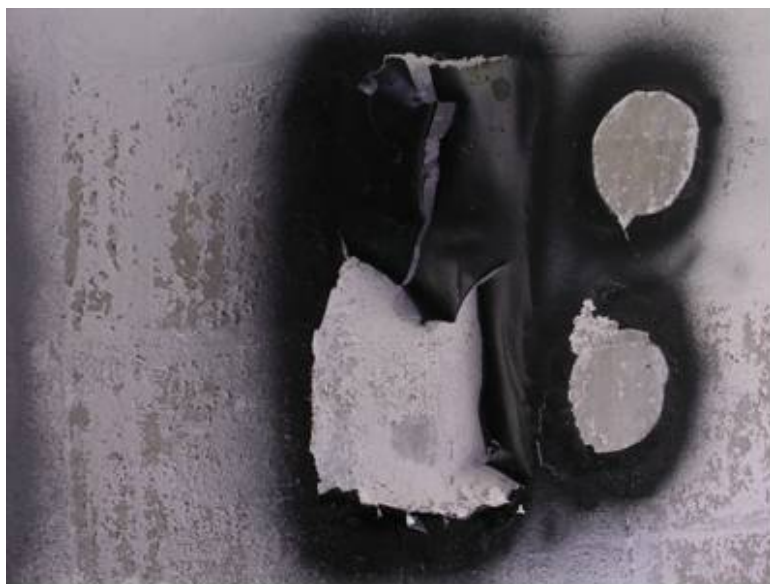
Figure 5-46. NM-VP prior to three week sampling at 6819-11.

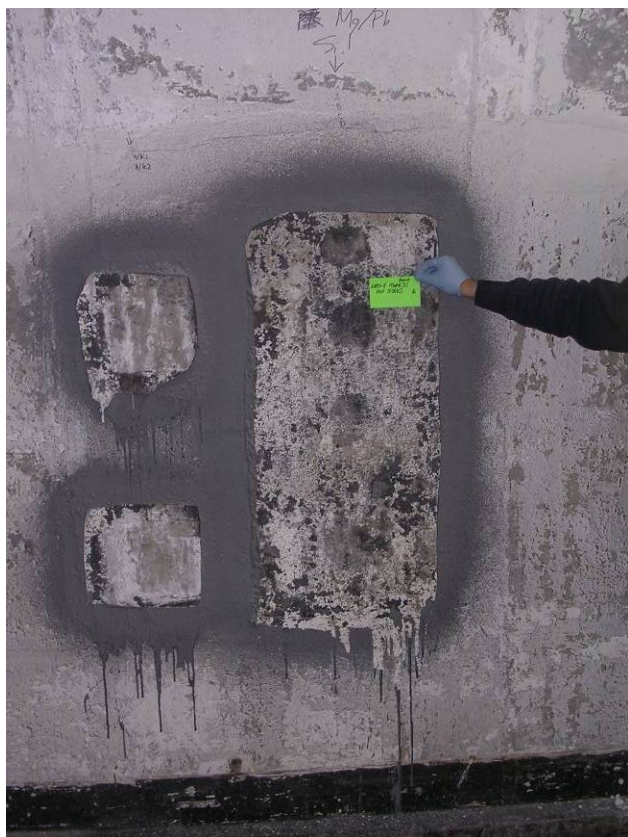
Figure 5-48. Mg/Pd-silicon after three week sampling event, 6810-11.

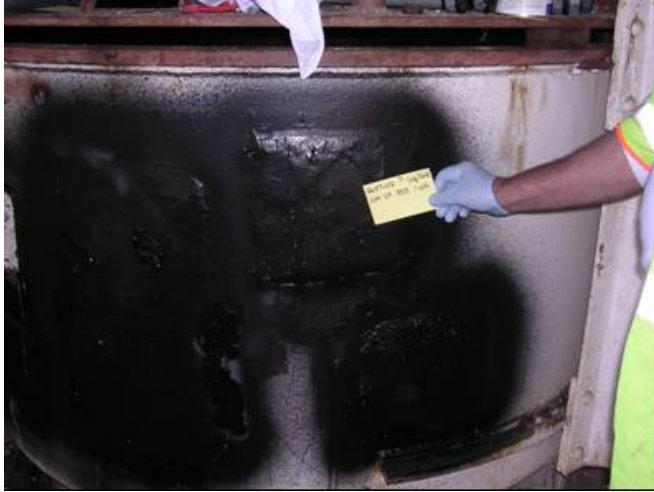
Figure 5-56. Large tank treated with Mg/Pd-VP and NM-VP one week after application.

Samples were collected of the paint, paste and sealant on each of the tanks that were treated after one week, two weeks and three weeks. Figure 5-56 shows the large tank after one week and as can be seen, the treated sections are still intact. Figure 5-57 shows the one week NM-VP sample being taken and Figure 5-58 shows the one week Mg/Pd-VP sample being taken. Figure 5-59 shows that the 3 ft<sup>2</sup> section on the small tank that was treated with the silicon polymer failed after one week. This section was to be sampled after three weeks of treatment, however, it was decided to take the one week sample from this section and then take the two and three week samples from the 1 ft<sup>2</sup> sections that were still intact.

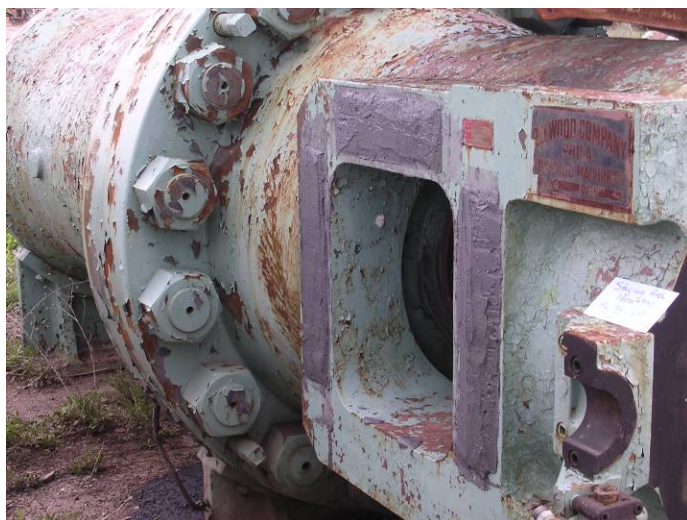
Figure 5-85. Quality of the paint on the presses in the staging area.
